Manhole Inspection Summary

Manhole # S61A1_005MH

Insp Date: **12/18/08 3:26 PM**

Location Address: **5001 Keith Ave.**

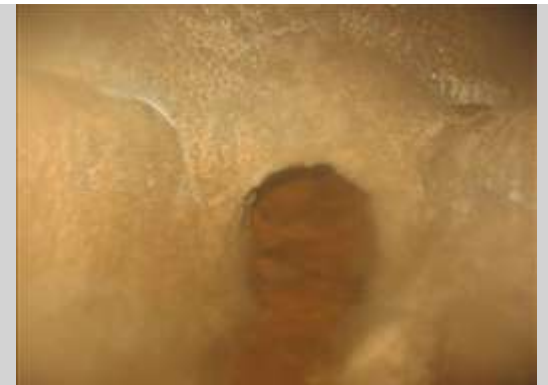
2 O'Clock Inflow

10 in. Circular Gravity Sewer
Pipe In @ 2 O'Clock

Pipe Height: **9.6** (in.) Rod and Bar (Angled)
Pipe Material: **Clay** ☐ Pipe Lined
Invert Depth: **27.83** (ft.) Flow Characteristics: **None**
Deposits: ☒ None ☐ Mud ☐ **Sludge** ☐ Debris ☐ Grease
Silt Depth: (in.) Deposits Extent:
Infiltration: **None** Pipe Seal Cond: **Sound**

Connects To: **House connection / Service line**

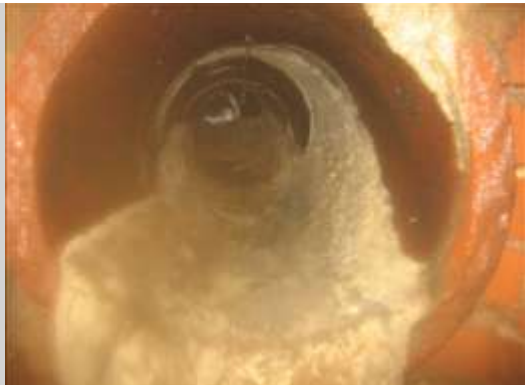
9 O'Clock Inflow

15 in. Circular Gravity Sewer

Pipe In @ 9 O'Clock

Pipe Height: **14.4** (in.) Rod and Bar (Angled)

Pipe Material: **Clay** ☐ Pipe Lined

Invert Depth: **10.00** (ft.) Flow Characteristics: **Slow**

Deposits: ☒ **None** ☐ Mud ☐ Sludge ☐ Debris ☐ Grease

Infiltration: **None** Pipe Seal Cond: **Sound**

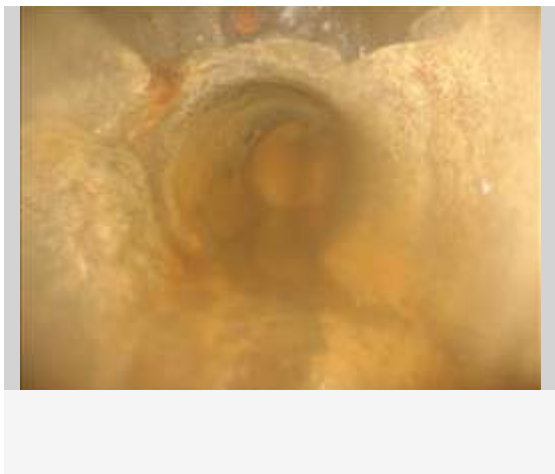
10 O'Clock Inflow

10 in. Circular Gravity Sewer
Pipe In @ 10 O'Clock

Pipe Height: **9.6** (in.) Rod and Bar (Angled)
Pipe Material: **Clay** ☐ Pipe Lined
Invert Depth: **28.00** (ft.) Flow Characteristics: **Slow**
Deposits: ☒ None ☐ Mud ☐ Sludge ☐ Debris ☐ Grease
Silt Depth: (in.) Deposits Extent:
Infiltration: **None** Pipe Seal Cond: **Sound**
